SUMMARY OF GOFFSTOWN PEDESTRIAN INFRASTRUCTURE

February 2024

Analysis of data collected for the NH SADES pedestrian infrastructure database.

Goffstown Pedestrian Infrastructure Report

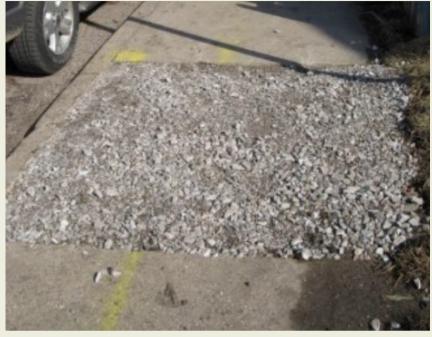
The image on the right depicts an area of sidewalk that is missing material.

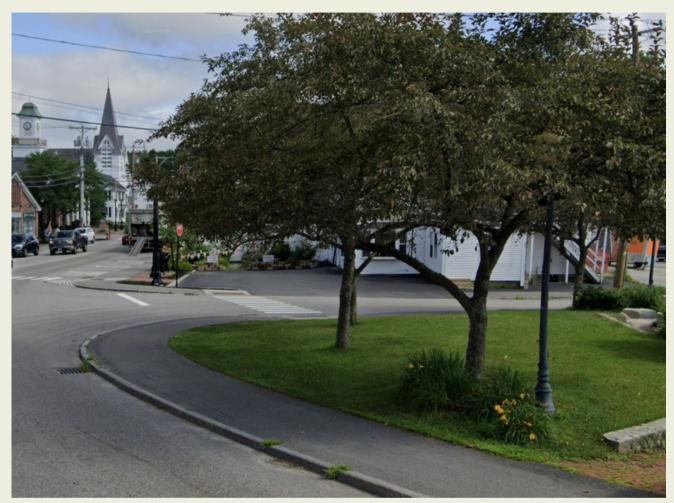
The tree branches in the image above impact vertical passage on the sidewalk adjacent to the trees. If vegetation is not trimmed, branches can impact sidewalk use for pedestrians whose height may exceed low hanging branches.

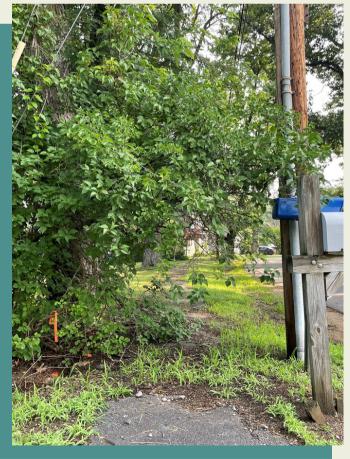
The sidewalk below is located on Shirley Park Road. Plant overgrowth and uneven conditions make it unpassable, resulting in pedestrian travel on the adjacent road.

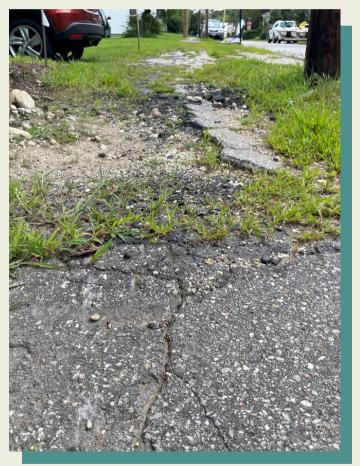
The sidewalk above is located on West Union Street, which is in poor condition due to missing material and cracks.

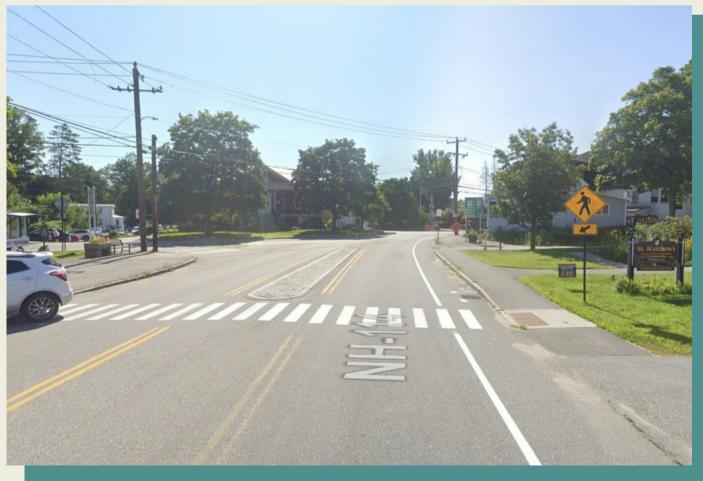
The crosswalk below is on North Mast St and features a curb ramp that connects to a crosswalk that includes a pedestrian crossing sign.

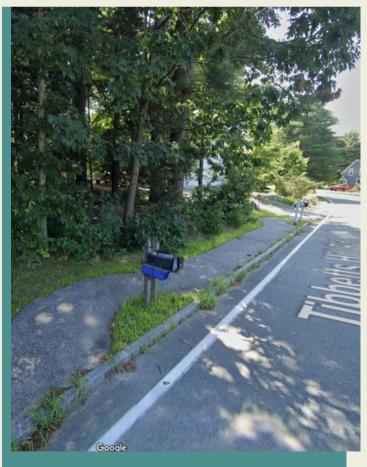
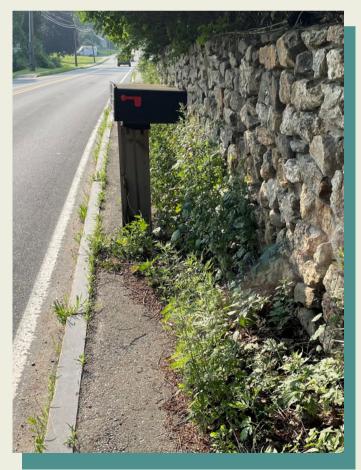
The image on the left features a sidewalk on Tibbetts Hill Road that is in fair condition. It has been designed to accommodate passage around mailboxes. In the image on the right, plant overgrowth and a mailbox prevent passage near the Tibbetts Hill Road intersection on Center St.

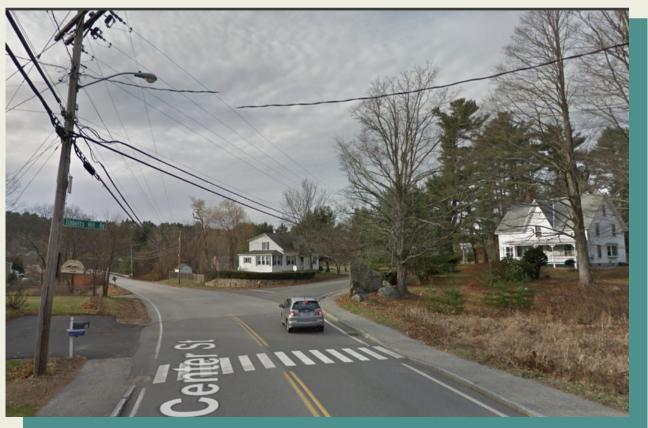
The image below features a crosswalk on Center Street that is illuminated in lowlight conditions by an overhead streetlight.

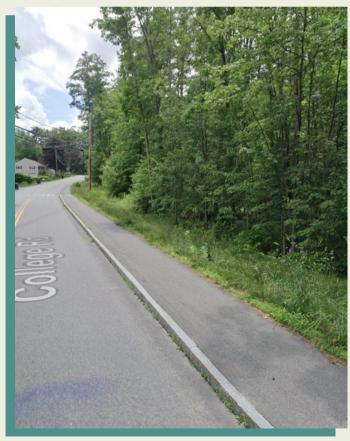
The sidewalk below is located on College Road near the intersection with Roy Street, and is in good condition.

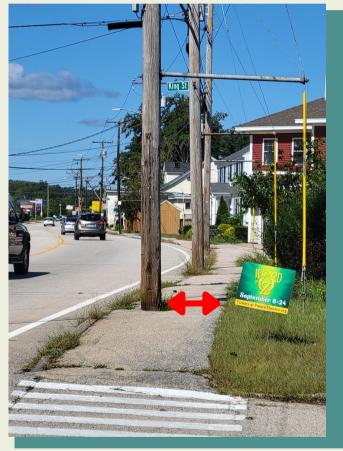
The sidewalk above is on Mast Road at the intersection with Laurier Street. The telephone pole reduces passable sidewalk width to 32 inches, which could pose an obstacle to a person with disabilities.

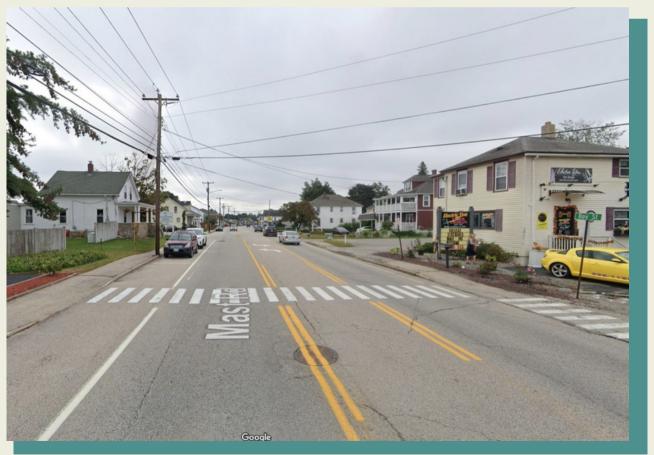
The crosswalk pictured below is located on Mast Road, and is one of 57 crosswalks without pedestrian crossing signs in Pinardville.
